# Failure analysis of compressor & camshaft gear— An experimental approach

Arvind Yadav

**Abstract-** This paper reports the result of an investigation of premature failure of compressor gear, camshaft gear (ie; spur gear). In this paper three 1616 CR BS III Engine investigated for subjected to matter in different types of H series vehicle. A standard investigation procedure was employed in this analysis under various conditions. It was found by analyzing various observations the gear shaft was bending and teeth failure on endurance on engine occurred under these testing ,in this paper overload test engine (on test bed ) and different types of vehicle used for testing by running them at different-different speed and distance to calculate accurate reason of gear failure.

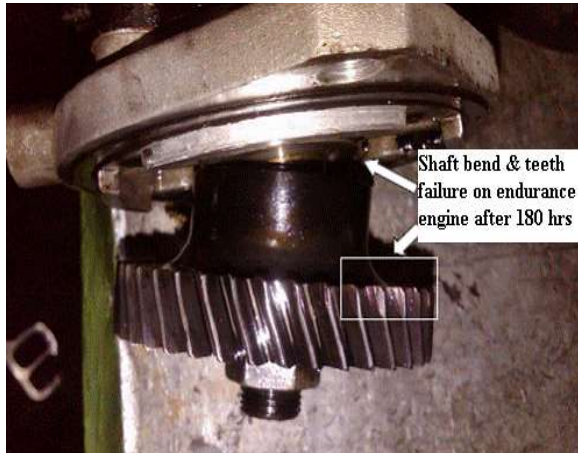
Fig1 Teeth Failure of Gear

- The shaft of the air compressor gear is bent and the gear has come out of the engagement from camshaft gear
- The air compressor shaft can be rotated only for part of the revolution; subsequent to this it gets locked. When the compressor head was opened it was observed that inlet valve head was broken and got entrapped between the piston and the cylinder head, preventing the rotation of the compressor camshaft.
- The air compressor gear can be rotated on the compressor shaft. Some material adhesion is observed on the cone ID of the gear.

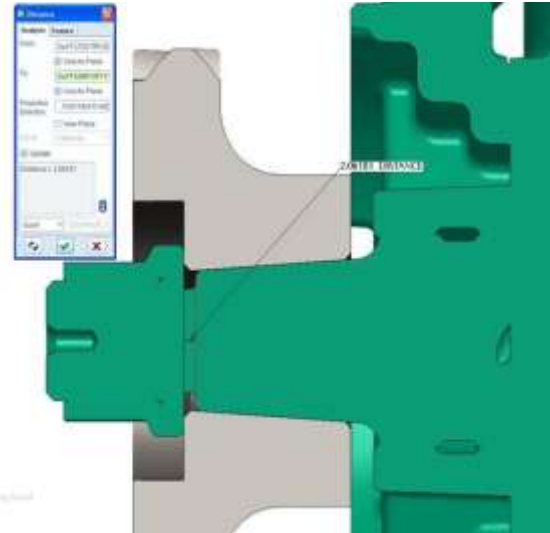
Wabco have indicated the design of gear and its fastening is investigated in view of the rotation possibility. As seen from snapshot below, the distance between the gear clamping face and end of cone in 2 mm, this will always ensure that the gear is rigidly clamped on the cone surface.

Fig.2 shows snapshot image of clamping arrangement

Going by the preliminary investigation by the supplier the possibility of nut loose cannot be overruled as we had already taken up with JSR regarding such cases observed earlier on two occasions'. While as mentioned in the investigation this doesn't answer for the inlet valve breakage issue (which could also be the root cause of failure: valve head breakage leading to physical locking of the piston motion, creating a shock load and hence bending of the compressor shaft)

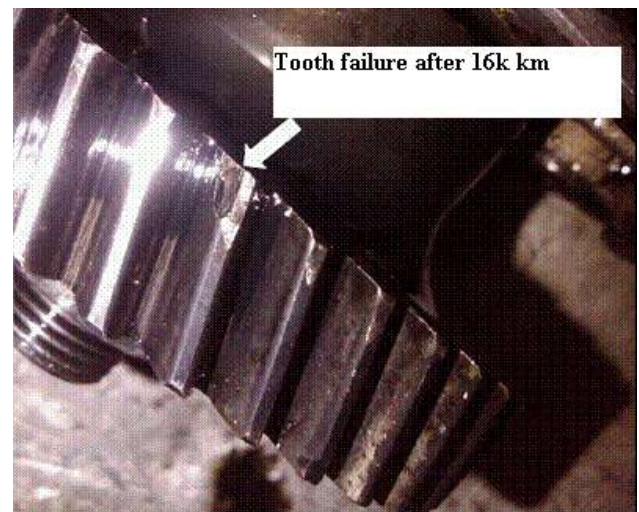
Fig.3 teeth failure camshaft gear after 16k km running.

- a. The compressor gear has got inner corner material dislodged on two of its teeth. This is typical case of edge loading of the gears which could be due to issue of parallelism of the two shafts (air compressor gear drive shaft and the camshaft drive shaft).
- b. Camshaft gear
  - i. There is material erosion on the camshaft teeth on non driving flank wrt FIP / compressor gear. The back face of the camshaft gear shows rubbing marks on the face. And material of ~1.5 mm depth is cut out on the Timing gear housing corresponding to this face.

The damage observed in points a & b above will be due to the TGH material cut out getting entrapped

between the gear teeth leading to damage / parallelism issues.

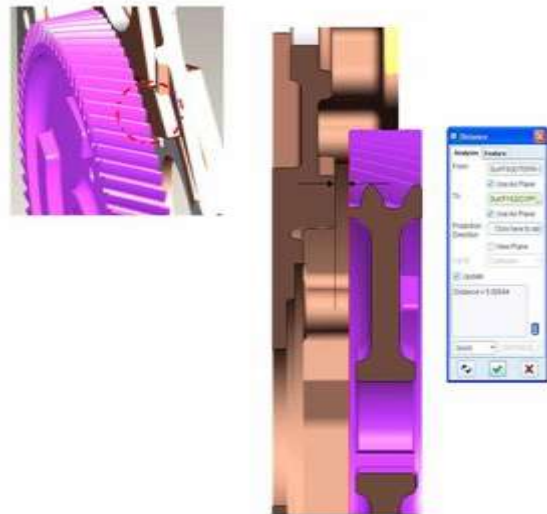
Typically in assembled condition there is a gap of around 5 mm between the camshaft gear face and the TGH (as shown in snap below). This type of rubbing could be explained if the spacer / thrust washer is not assembled during the engine assembly and the camshaft gear shifts back leading to rubbing against the TGH.

Fig.4 snapshot image of clamping arrangement of cam gear

ii. While during investigation of this case we found that camshaft gear was 5 mm away from the TGH face as required in design, but the above rubbing marks and the material cut in TGH indicate that at some earlier stage the possibility identified in point 1 must have occurred.

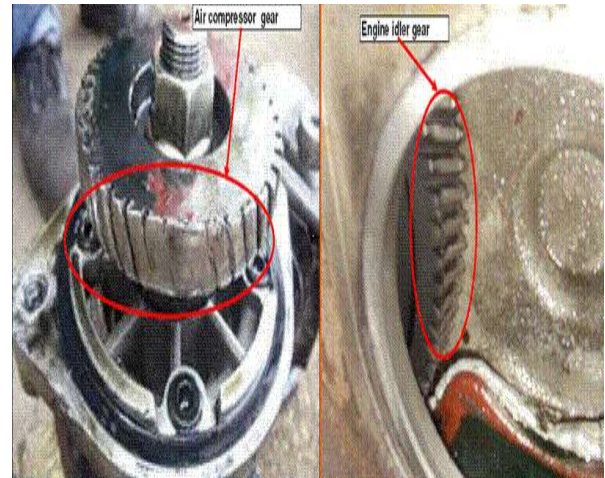
Fig.5 air compressor teeth failure

- a. Vehicles run for 20K kms.
- b. Camshaft gear: The gear teeth are cut off unevenly (radially) over circumference.
- c. Compressor gear: The teeth are burnished. The burnishing phenomenon is observed to be eccentric to centre (some teeth are burnished close to root while the others are close to the gear tip)
- d. One of the compressor mounting bolts was found in loose condition.

- there is some foreign particle getting entrapped in camshaft and compressor gear, leading to the teeth breakage of the camshaft gear and the consequential failure on compressor gear there on.
- there is some locking / shock load coming from the driven gear (air compressor gear). The air compressor was investigated at the suppliers end and was reported to be OK. As such the reason for shock load / locking needs to be understood from vehicle application point of view.
